**Flood Control Project Maintenance  
Levee Inspections**

## Maintenance Issue Types Only, Levee Inspection Report By Mile - Spring 2017

### Sutter Maintenance Yard Wadsworth Canal

Waterway	Bank	Unit Miles	Inspection Start/End	Inspector
Unit No. 01 Wadsworth Canal	Left	4.63	04/11/2017 04/11/2017	Bob Duffey

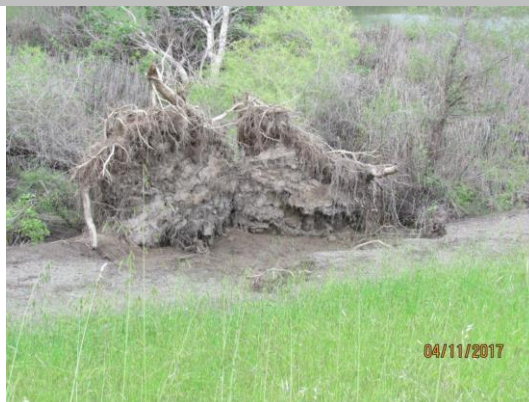
Photo 1 of 1 : SP\_2017\_ST0010\_42\_18\_20170413\_00030.jpg

LM Start	0.56	Rating **	U	Issue No.	18
LM End	0.56	Issue Type +	Ma	Location *	WS
Category	Earthen Levee			GPS Latitude/Longitude	
				Start	End
Item	Erosion / Bank Caving			39.119985 °	39.119985 °
				-121.762600 °	-121.762600 °
DWR ID	DWR_ST0010_01_s _ 2017_18				
Comment Code					
E2 : Schedule repair of erosion site prior to the next inspection.					
Inspector Comment					
Repair the erosion along the water side toe.

View of the erosion along the waterside toe caused by a tree that fell into the water.

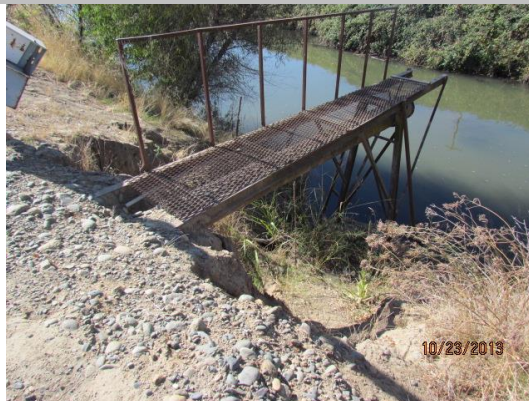
Photo 1 of 3 : SP\_2017\_ST0010\_42\_107\_20170315\_00014.jpg

LM Start	1.85	Rating **	U	Issue No.	107
LM End	1.85	Issue Type +	Ma	Location *	WS
Category	Earthen Levee			GPS Latitude/Longitude	
				Start	End
Item	Erosion / Bank Caving			39.135110 °	39.135110 °
				-121.748230 °	-121.748230 °
DWR ID	DWR_ST0010_01_f_2013_107				
Comment Code					
E2 : Schedule repair of erosion site prior to the next inspection.					
Inspector Comment					
Repair the erosion under the abandoned pump.

View of the erosion along both sides of the abandoned pump.

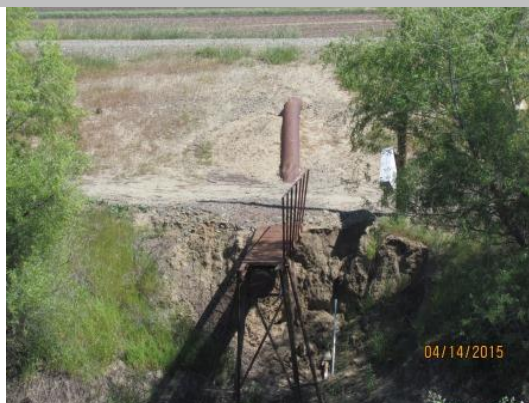
Photo 2 of 3 : SP\_2017\_ST0010\_42\_107\_20170315\_00015.jpg

View of the erosion along both sides of the abandoned pump.

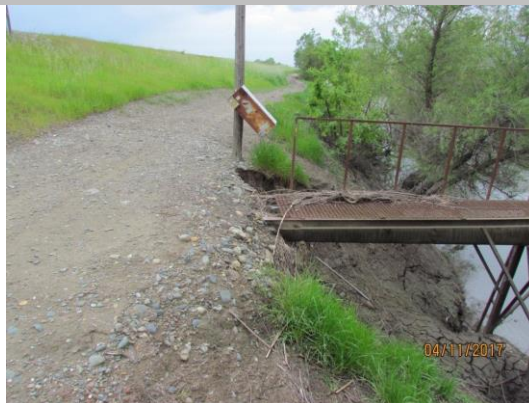
Photo 3 of 3 : SP\_2017\_ST0010\_42\_107\_20170413\_00029.jpg

View of erosion along both sides of the abandoned pipe.

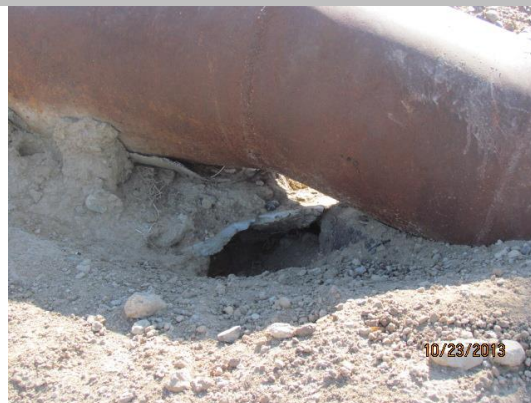
Photo 1 of 1 : SP\_2017\_ST0010\_42\_106\_20170315\_00013.jpg

LM Start	1.85	Rating **	M	Issue No.	106
LM End	1.85	Issue Type +	Ma	Location *	WS
Category	Earthen Levee			GPS Latitude/Longitude	
				Start	End
Item	Animal Control			39.135110 °	39.135110 °
				-121.748229 °	-121.748229 °
DWR ID	DWR_ST0010_01_f_2013_106				
Comment Code					
A3 : No rodents visible, but rodent burrows visible; need to backfill and compact or grout burrows.					
Inspector Comment

View of the rodent holes under the irrigation pipe.

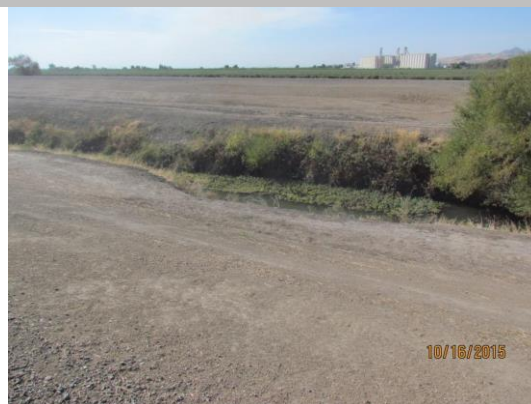
Photo 1 of 4 : SP\_2017\_ST0010\_42\_6\_20170315\_00006.jpg

LM Start	2.43	Rating **	M	Issue No.	6
LM End	3.30	Issue Type +	Ma	Location *	WS
Category	Supplemental			GPS Latitude/Longitude	
				Start	End
Item	2015 USACE Erosion Survey, DRAFT			39.142235 °	39.153095 °
				-121.742609 °	-121.734390 °
DWR ID	DWR_ST0010_01_f_2015_6				
Comment Code					
Inspector Comment					
2010 - Over steepened levees, some slumping, reach-wide problem.					
2011 - Still a reach-wide problem. 2015: Site is part of the extended inventory, last inspected 2011. [2015 Site ID: WAD_2-4_L]

View of the erosion along the waterside toe.

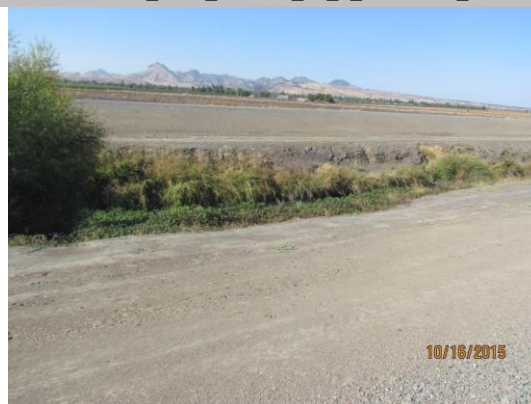
Photo 2 of 4 : SP\_2017\_ST0010\_42\_6\_20170315\_00007.jpg

View of the erosion along the waterside toe.

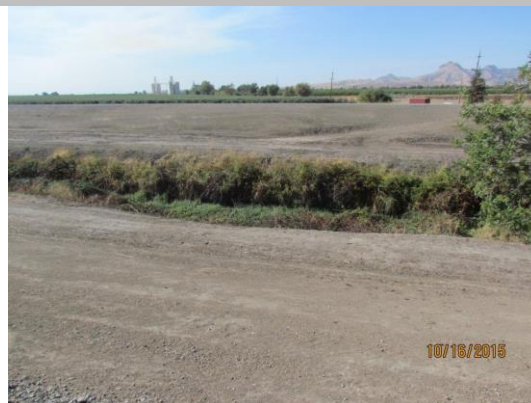
Photo 3 of 4 : SP\_2017\_ST0010\_42\_6\_20170315\_00008.jpg

View of the erosion along the waterside toe.

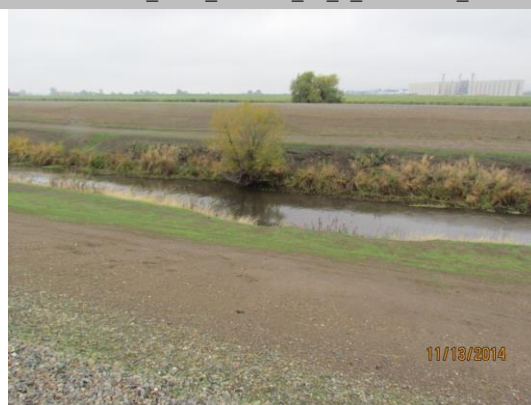
Photo 4 of 4 : SP\_2017\_ST0010\_42\_6\_20170315\_00009.jpg

View of the erosion along the waterside toe.

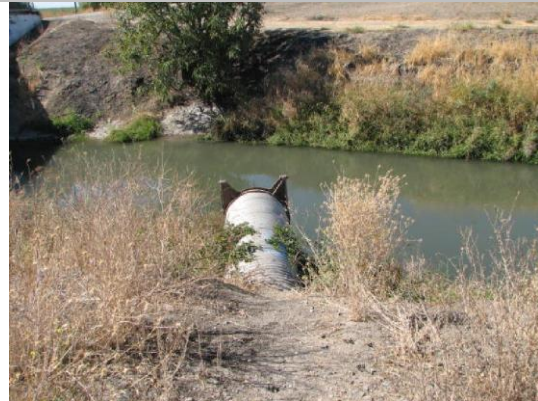
Photo 1 of 3 : UCIP\_SP\_2017\_51500\_64718.jpg

FS\_ID:51500  
DS\_ID:17065  
EP\_NO: 7209  
Repair Type: Non-Urgent  
Crossing Status: Found  
UCIP Comments: 4/10/2017 Ws pipe end is in good condition. LS pipe end is still deformed and vegetated. (DWR Sutter Yard-AFreitag)10/12/2016 LS inlet is still deformed and being overgrown by vegetation.(DWR Sutter Yard - aFreitag)4/19/2016 Crossing appears to be in good condition.5/12/2015 LS inlet still deformed a little but does not affect the crossing function.11/18/2014 Same as last inspection.5/13/2014 Same as last inspection.10/29/2013 Same as last inspection.5/16/2013 Pipe intake on LS appears to be bent and damaged but that does not appear to be affecting water flow or channel bank.  
FIELD\_STRUCT\_DESC: 36-inch corrugated metal drainage pipe (permit records indicate 30-inch USACE O&M pipe replaced with new 30-inch pipe) through the levee, 9 feet below the crown. Flap gate located on the waterside (WS) end. (original O&M manual crossing was replaced under Permit No. 7209, 1970 - Department of Water Resources) [Additional Reference(s): DWR Levee Log, 2005. USACE Sacramento O&M Manual 135, May 1953, (Station 160+25)].

36-inch pipe with flapgate on WS slope.

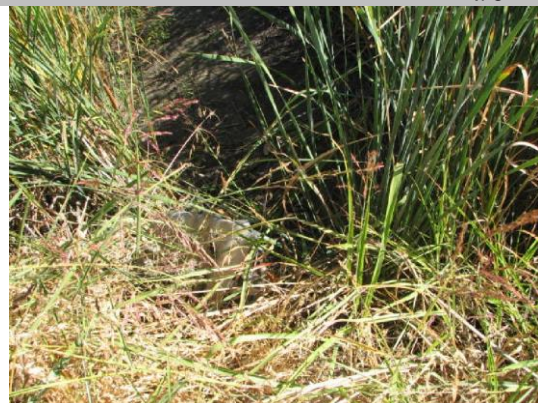
Photo 2 of 3 : UCIP\_SP\_2017\_51500\_64717.jpg

Inlet in weeds on LS toe.

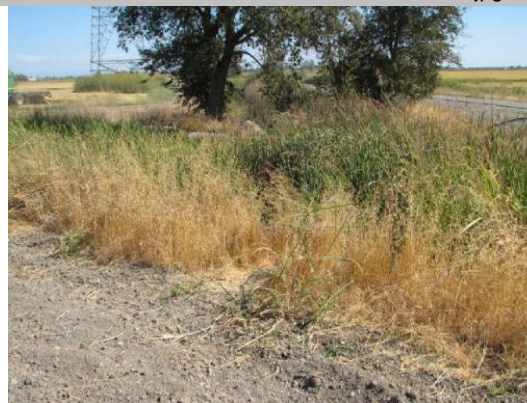
Photo 3 of 3 : UCIP\_SP\_2017\_51500\_64716.jpg

FS\_ID:51500  
DS\_ID:17065  
EP\_NO: 7209  
Repair Type: Non-Urgent  
Crossing Status: Found  
UCIP Comments: 4/10/2017 Ws pipe end is in good condition. LS pipe end is still deformed and vegetated. (DWR Sutter Yard-AFreitag)10/12/2016 LS inlet is still deformed and being overgrown by vegetation.(DWR Sutter Yard - aFreitag)4/19/2016 Crossing appears to be in good condition.5/12/2015 LS inlet still deformed a little but does not affect the crossing function.11/18/2014 Same as last inspection.5/13/2014 Same as last inspection.10/29/2013 Same as last inspection.5/16/2013 Pipe intake on LS appears to be bent and damaged but that does not appear to be affecting water flow or channel bank.  
FIELD\_STRUCT\_DESC: 36-inch corrugated metal drainage pipe (permit records indicate 30-inch USACE O&M pipe replaced with new 30-inch pipe) through the levee, 9 feet below the crown. Flap gate located on the waterside (WS) end. (original O&M manual crossing was replaced under Permit No. 7209, 1970 - Department of Water Resources) [Additional Reference(s): DWR Levee Log, 2005. USACE Sacramento O&M Manual 135, May 1953, (Station 160+25)].

Pipe inlet heavily shielded by vegetation.

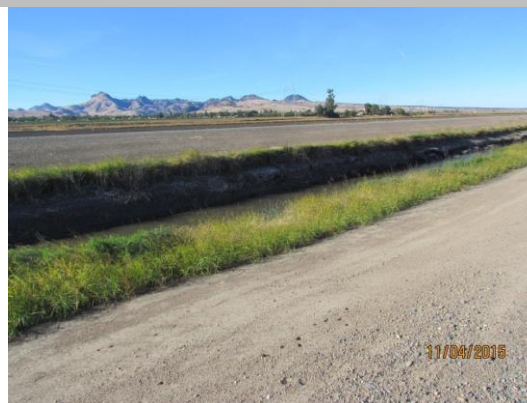
Photo 1 of 1 : SP\_2017\_ST0010\_42\_3\_20170315\_00001.jpg

E1 : Note and monitor erosion site.

View of the erosion along the waterside toe.

Monitor the erosion along the waterside toe.

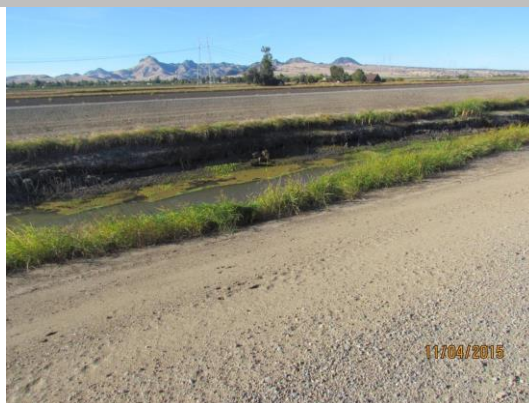
Photo 2 of 2 : SP\_2017\_ST0010\_42\_4\_20170315\_00003.jpg

View of the erosion along the waterside toe.

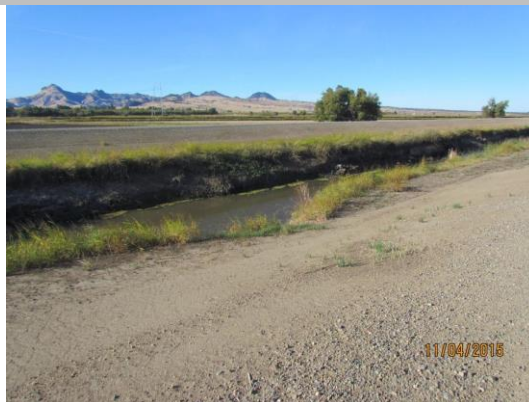
Photo 1 of 1 : SP\_2017\_ST0010\_42\_17\_20170315\_00010.jpg

LM Start	3.84	Rating **	M	Issue No.	17
LM End	3.85	Issue Type +	Ma	Location *	WS
Category	Earthen Levee			GPS Latitude/Longitude	
				Start	End
Item	Erosion / Bank Caving			39.160442 °	39.160517 °
				-121.731067 °	-121.731137 °
DWR ID	DWR_ST0010_01_f_2014_17				
Comment Code					
E1 : Note and monitor erosion site.					
Inspector Comment					
Monitor the erosion along the waterside toe.

View of the erosion along the waterside toe.

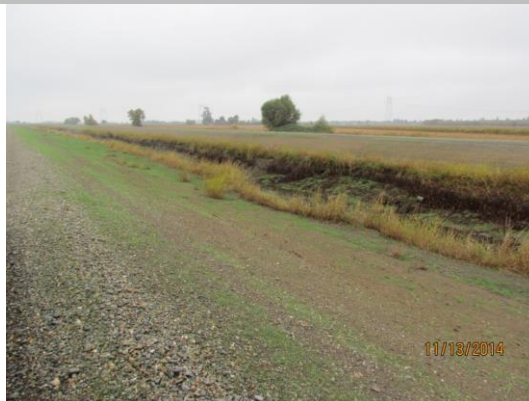
Photo 1 of 2 : SP\_2017\_ST0010\_42\_5\_20170315\_00004.jpg

LM Start	4.23	Rating **	M	Issue No.	5
LM End	4.23	Issue Type +	Ma	Location *	WS
Category	Earthen Levee			GPS Latitude/Longitude	
				Start	End
Item	Erosion / Bank Caving			39.165845 °	39.165845 °
				-121.728877 °	-121.728877 °
DWR ID	DWR_ST0010_01_s_2012_5				
Comment Code					
E1 : Note and monitor erosion site.					
Inspector Comment					
Monitor the erosion along the waterside toe.

View of the erosion along the waterside toe.

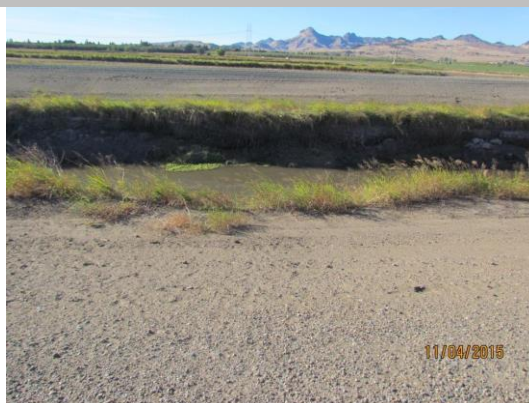
Photo 2 of 2 : SP\_2017\_ST0010\_42\_5\_20170315\_00005.jpg

View of the erosion along the waterside toe.

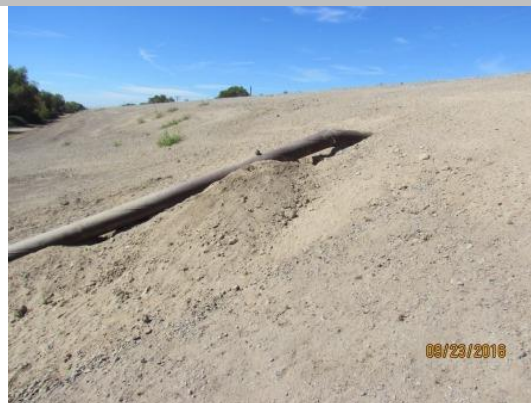
Photo 1 of 2 : SP\_2017\_ST0010\_43\_19\_20170315\_00014.jpg

LM Start	1.16	Rating **	U	Issue No.	19
LM End	1.16	Issue Type +	Ma	Location *	WS
Category	Earthen Levee			GPS Latitude/Longitude	
				Start	End
Item	Animal Control			39.127527 °	39.127527 °
				-121.756493 °	-121.756493 °
DWR ID	DWR_ST0010_02_f_2016_19				
Comment Code					
A3 : No rodents visible, but rodent burrows visible; need to backfill and compact or grout burrows.					
Inspector Comment					
Repair the rodent holes along the waterside slope.

View of the rodent holes along the waterside slope.

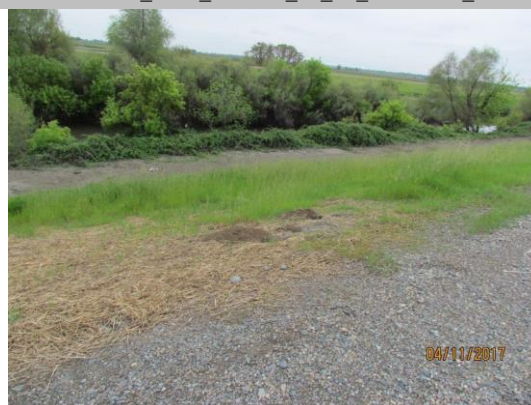
Photo 2 of 2 : SP\_2017\_ST0010\_43\_19\_20170413\_00035.jpg

View of the rodent holes along the waterside slope.

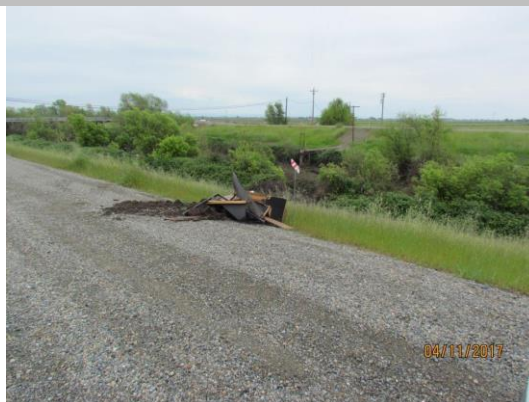
Photo 1 of 1 : SP\_2017\_ST0010\_43\_23\_20170413\_00037.jpg

LM Start	1.17	Rating **	M	Issue No.	23
LM End	1.17	Issue Type +	Ma	Location *	WS
Category	Earthen Levee			GPS Latitude/Longitude	
				Start	End
Item	Encroachments			39.127727 °	39.127727 °
				-121.756308 °	-121.756308 °
DWR ID	DWR_ST0010_02_s_2017_23				
Comment Code					
GA : Garbage					
Inspector Comment					
Remove the garbage from the waterside slope.

View of the garbage along the waterside slope.

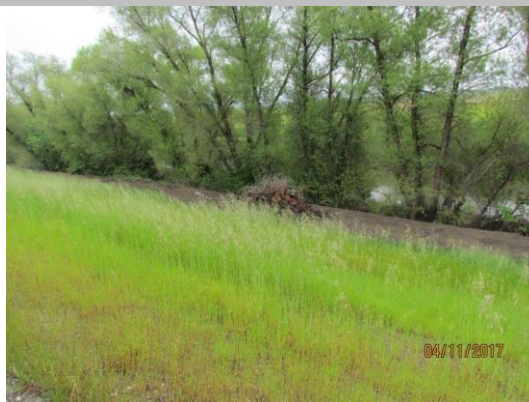
Photo 1 of 1 : SP\_2017\_ST0010\_43\_24\_20170413\_00038.jpg

LM Start	1.68	Rating **	M	Issue No.	24
LM End	1.68	Issue Type +	Ma	Location *	WS
Category	Earthen Levee			GPS Latitude/Longitude	
				Start	End
Item	Encroachments			39.133602 °	39.133602 °
				-121.750545 °	-121.750545 °
DWR ID	DWR_ST0010_02_s_2017_24				
Comment Code					
PR : Prunings					
Inspector Comment					
Remove the prunings from the waterside toe.

View of the prunings along the waterside toe.

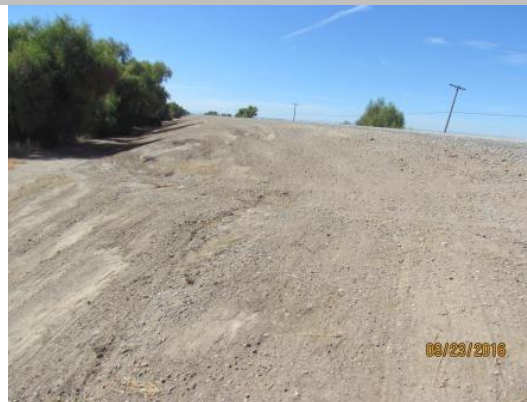
Photo 1 of 1 : SP\_2017\_ST0010\_43\_20\_20170315\_00015.jpg

LM Start	1.75	Rating **	M	Issue No.	20
LM End	1.75	Issue Type +	Ma	Location *	WS
Category	Earthen Levee			GPS Latitude/Longitude	
				Start	End
Item	Slope Stability			39.134378 °	39.134378 °
				-121.749803 °	-121.749803 °
DWR ID	DWR_ST0010_02_f_2016_20				
Comment Code					
S3 : Repair the levee slope damaged by vehicle traffic and prevent access where possible.					
Inspector Comment					
Ramp is causing depression in the levee slope.

View the ramp encroaching into the levee.

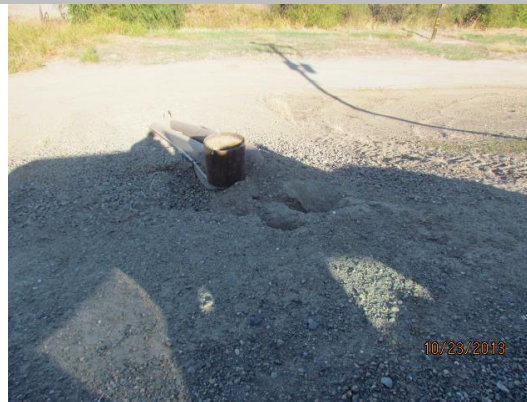
Photo 1 of 2 : SP\_2017\_ST0010\_43\_11\_20170315\_00012.jpg

LM Start	1.76	Rating **	M	Issue No.	11
LM End	1.76	Issue Type +	Ma	Location *	LS
Category	Earthen Levee			GPS Latitude/Longitude	
				Start	End
Item	Animal Control			39.134490 °	39.134490 °
				-121.749716 °	-121.749716 °
DWR ID	DWR_ST0010_02_f_2012_11				
Comment Code					
A3 : No rodents visible, but rodent burrows visible; need to backfill and compact or grout burrows.					
Inspector Comment					
Repair the rodent hole.

View of the rodent holes above the irrigation pipe.

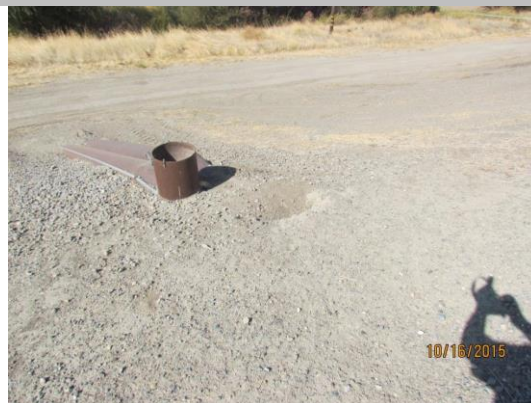
Photo 2 of 2 : SP\_2017\_ST0010\_43\_11\_20170315\_00013.jpg

LM Start	1.76	Rating **	M	Issue No.	11 (cont)	
LM End	1.76	Issue Type +	Ma	Location *	LS	
Category	Earthen Levee			GPS Latitude/Longitude		
				Start		End
Item	Animal Control			39.134490 °		39.134490 °
				-121.749716 °		-121.749716 °
DWR ID	DWR_ST0010_02_f_2012_11					
Comment Code						
A3 : No rodents visible, but rodent burrows visible; need to backfill and compact or grout burrows.						
Inspector Comment						
Repair the rodent hole.

View of the rodent hole above the irrigation pipe.

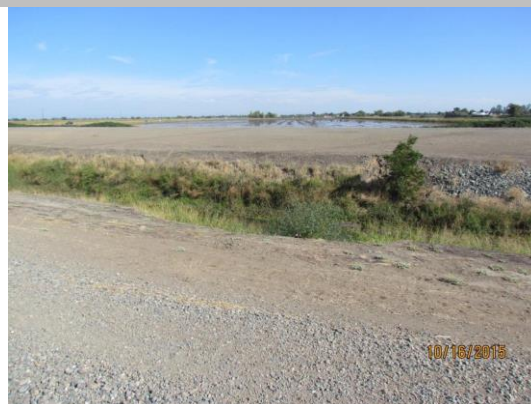
Photo 1 of 2 : SP\_2017\_ST0010\_43\_8\_20170315\_00008.jpg

LM Start	2.41	Rating **	M	Issue No.	8
LM End	3.28	Issue Type +	Ma	Location *	WS
Category	Supplemental			GPS Latitude/Longitude	
				Start	End
Item	2015 USACE Erosion Survey, DRAFT			39.142254 °	39.153150 °
				-121.742847 °	-121.734611 °
DWR ID	DWR_ST0010_02_s_2016_8				
Comment Code					
Inspector Comment					
2010 - Over steepened levees, some slumping, reach-wide problem. 2011 - Still a reach-wide problem. 2015: Site is part of the extended inventory, last inspected 2011. [2015 Site ID: WAD_2-4_R]

View of erosion along the waterside toe.

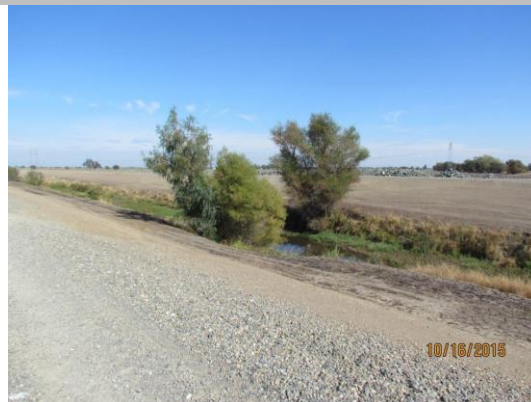
Photo 2 of 2 : SP\_2017\_ST0010\_43\_8\_20170315\_00009.jpg

View of the erosion along the landside toe.

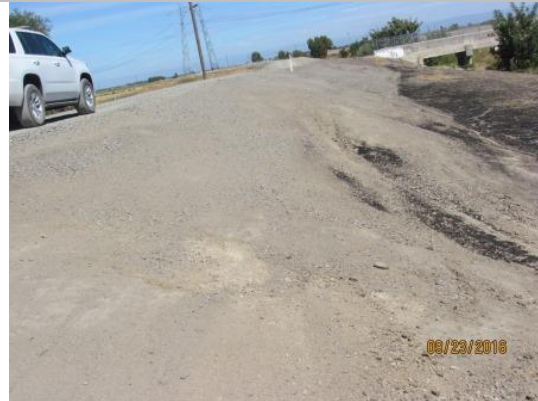
Photo 1 of 1 : SP\_2017\_ST0010\_43\_21\_20170315\_00016.jpg

LM Start	2.95	Rating **	M	Issue No.	21
LM End	2.95	Issue Type +	Ma	Location *	WS
Category	Earthen Levee			GPS Latitude/Longitude	
				Start	End
Item	Slope Stability			39.148938 °	39.148938 °
				-121.737620 °	-121.737620 °
DWR ID	DWR_ST0010_02_f_2016_21				
Comment Code					
S3 : Repair the levee slope damaged by vehicle traffic and prevent access where possible.					
Inspector Comment					
Ramp is causing depression in the levee slope.

View the ramp encroaching into the levee.

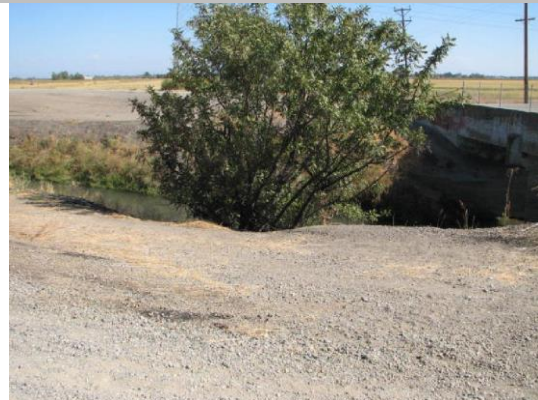
Photo 1 of 3 : UCIP\_SP\_2017\_51515\_64744.jpg

Comment Code					
Inspector Comment					
FS_ID:51515 DS_ID:17077 EP_NO: 7209 Repair Type: Non-Urgent Crossing Status: Found UCIP Comments: 4/10/2017 Tree still present and a problem at the WS pipe outlet. LS inlet is still vegetated. (DWR Sutter Yard-AFreitag)10/12/2016 Tree at the WS pipe end is still an issue and needs to be cut away. LS inlet is also being overgrown with vegetation.(DWR Sutter Yard - afreitag)4/19/2016 Tree at WS pipe end needs to be trimmed back and/or removed. 5/12/2015 Tree growing near WS pipe end is getting too big and will affect the crossing. It needs to be cut back or removed.11/18/2014 Same as last inspection.5/13/2014 Same as last inspection.10/29/2013 Same as last inspection.5/16/2013 Same as last inspection. FIELD_STRUCT_DESC: 36-inch corrugated metal drainage pipe (permit records indicate 30-inch pipe O&M pipe replaced with new 30-inch pipe) through the levee, 14 feet below the crown. Flap gate located on the waterside (WS) end. (original O&M manual crossing was replaced under Permit No. 7209, 1970 - Department of Water Resources) [Additional Reference(s): DWR Levee Log, 2005. USACE Sacramento O&M Manual 135, May 1953, (Station 158+35)]. FS Date: 4/12/2017 10:16:27 AM

Bush camouflaging outlet of pipe on WS slope.

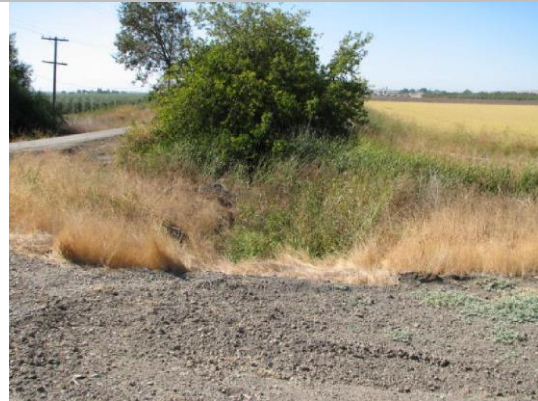
Photo 2 of 3 : UCIP\_SP\_2017\_51515\_64743.jpg

FS\_ID:51515  
DS\_ID:17077  
EP\_NO: 7209  
Repair Type: Non-Urgent  
Crossing Status: Found  
UCIP Comments: 4/10/2017 Tree still present and a problem at the WS pipe outlet. LS inlet is still vegetated. (DWR Sutter Yard-AFreitag)10/12/2016 Tree at the WS pipe end is still an issue and needs to be cut away. LS inlet is also being overgrown with vegetation.(DWR Sutter Yard - afreitag)4/19/2016 Tree at WS pipe end needs to be trimmed back and/or removed. 5/12/2015 Tree growing near WS pipe end is getting too big and will affect the crossing. It needs to be cut back or removed.11/18/2014 Same as last inspection.5/13/2014 Same as last inspection.10/29/2013 Same as last inspection.5/16/2013 Same as last inspection.  
FIELD\_STRUCT\_DESC: 36-inch corrugated metal drainage pipe (permit records indicate 30-inch pipe O&M pipe replaced with new 30-inch pipe) through the levee, 14 feet below the crown. Flap gate located on the waterside (WS) end. (original O&M manual crossing was replaced under Permit No. 7209, 1970 - Department of Water Resources) [Additional Reference(s): DWR Levee Log, 2005. USACE Sacramento O&M Manual 135, May 1953, (Station 158+35)].

Heavy vegetation at LS inlet at channel.

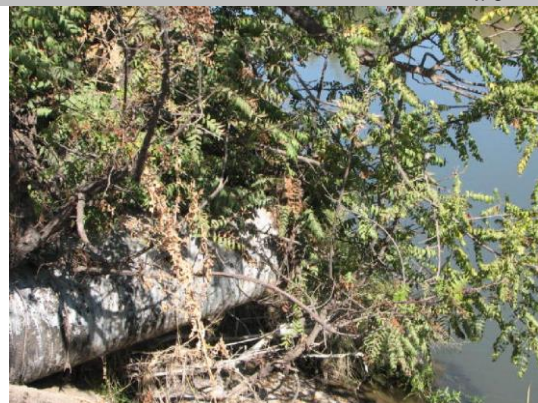
Photo 3 of 3 : UCIP\_SP\_2017\_51515\_64742.jpg

Pipe and flap gate at WS outlet.

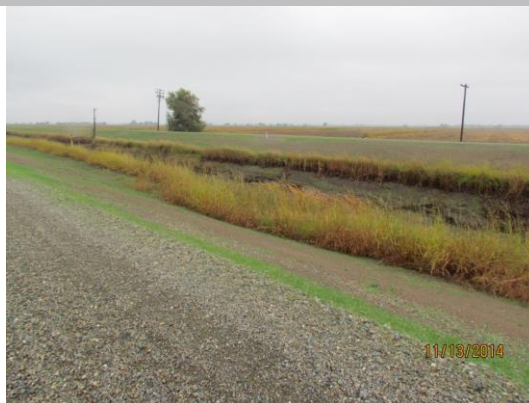
Photo 1 of 2 : SP\_2017\_ST0010\_43\_4\_20170315\_00002.jpg

View of the erosion at the waterside toe.

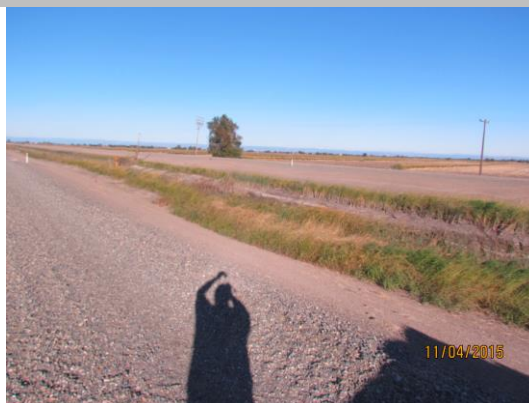
Photo 2 of 2 : SP\_2017\_ST0010\_43\_4\_20170315\_00003.jpg

View of the erosion at the waterside toe.

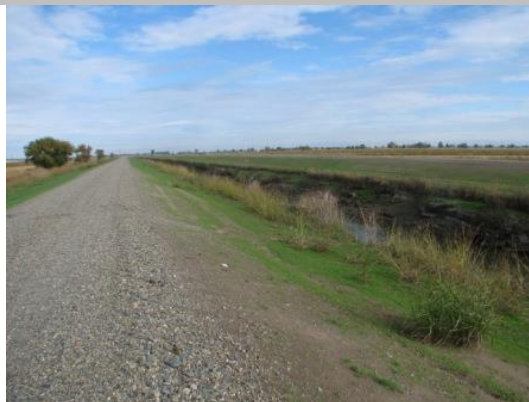
Photo 1 of 2 : SP\_2017\_ST0010\_43\_5\_20170315\_00004.jpg

LM Start	3.54	Rating **	M	Issue No.	5
LM End	3.93	Issue Type +	Ma	Location *	WS
Category	Earthen Levee			GPS Latitude/Longitude	
				Start	End
Item	Erosion / Bank Caving			39.156753 °	39.162113 °
				-121.733267 °	-121.730997 °
DWR ID	DWR_ST0010_02_s_2012_5				
Comment Code					
E1 : Note and monitor erosion site.					
Inspector Comment					
Monitor is the erosion at the waterside toe.

View of the erosion along the waterside toe.

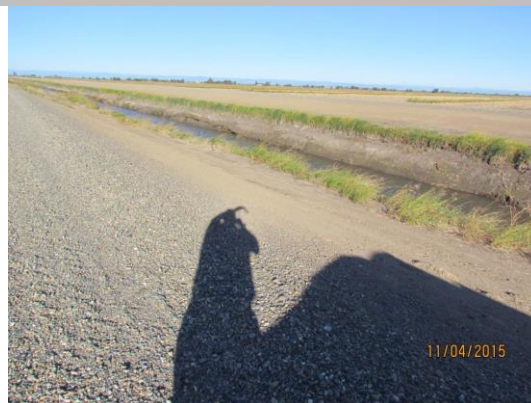
Photo 2 of 2 : SP\_2017\_ST0010\_43\_5\_20170315\_00005.jpg

View of erosion at the waterside toe

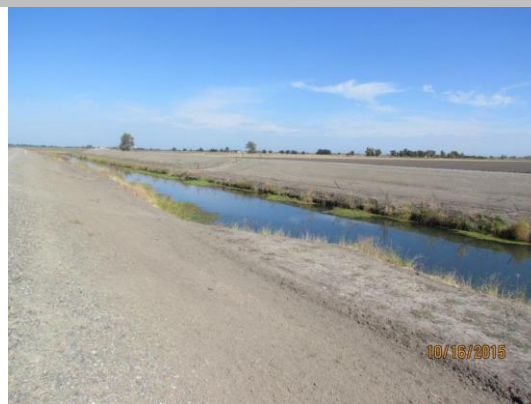
Photo 1 of 2 : SP\_2017\_ST0010\_43\_9\_20170315\_00010.jpg

LM Start	4.41	Rating **	M	Issue No.	9
LM End	4.43	Issue Type +	Ma	Location *	WS
Category	Supplemental			GPS Latitude/Longitude	
				Start	End
Item	2015 USACE Erosion Survey, DRAFT			39.168659 °	39.168937 °
				-121.728016 °	-121.727905 °
DWR ID	DWR_ST0010_02_s_2016_9				
Comment Code					
Inspector Comment					
2011 - Small erosion pocket. 2015: Site is part of the extended inventory, last inspected 2011. [2015 Site ID: WAD_4-3_R]

View of the erosion along the waterside toe.

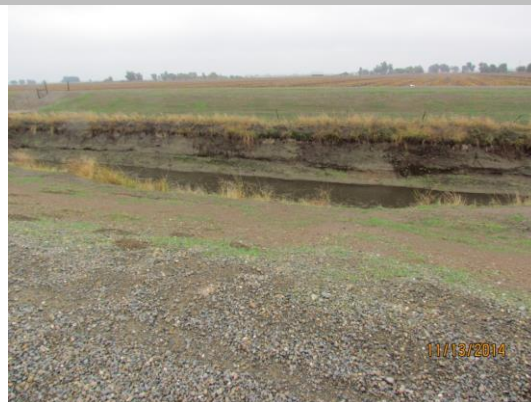
Photo 2 of 2 : SP\_2017\_ST0010\_43\_9\_20170315\_00011.jpg

View of the erosion along the waterside toe.

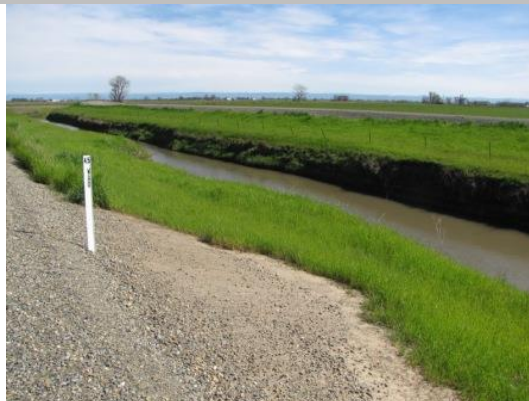
Photo 1 of 2 : SP\_2017\_ST0010\_43\_7\_20170315\_00006.jpg

View of the erosion along the W/S toe.
